B-4478

STOREFRONTS, 2334-36 PENNSYLVANIA AVENUE

BALTIMORE CITY, MD

MD INVENTORY OF HISTORIC PROPERTIES FORM
SANDTOWN-WINCHESTER SURVEY

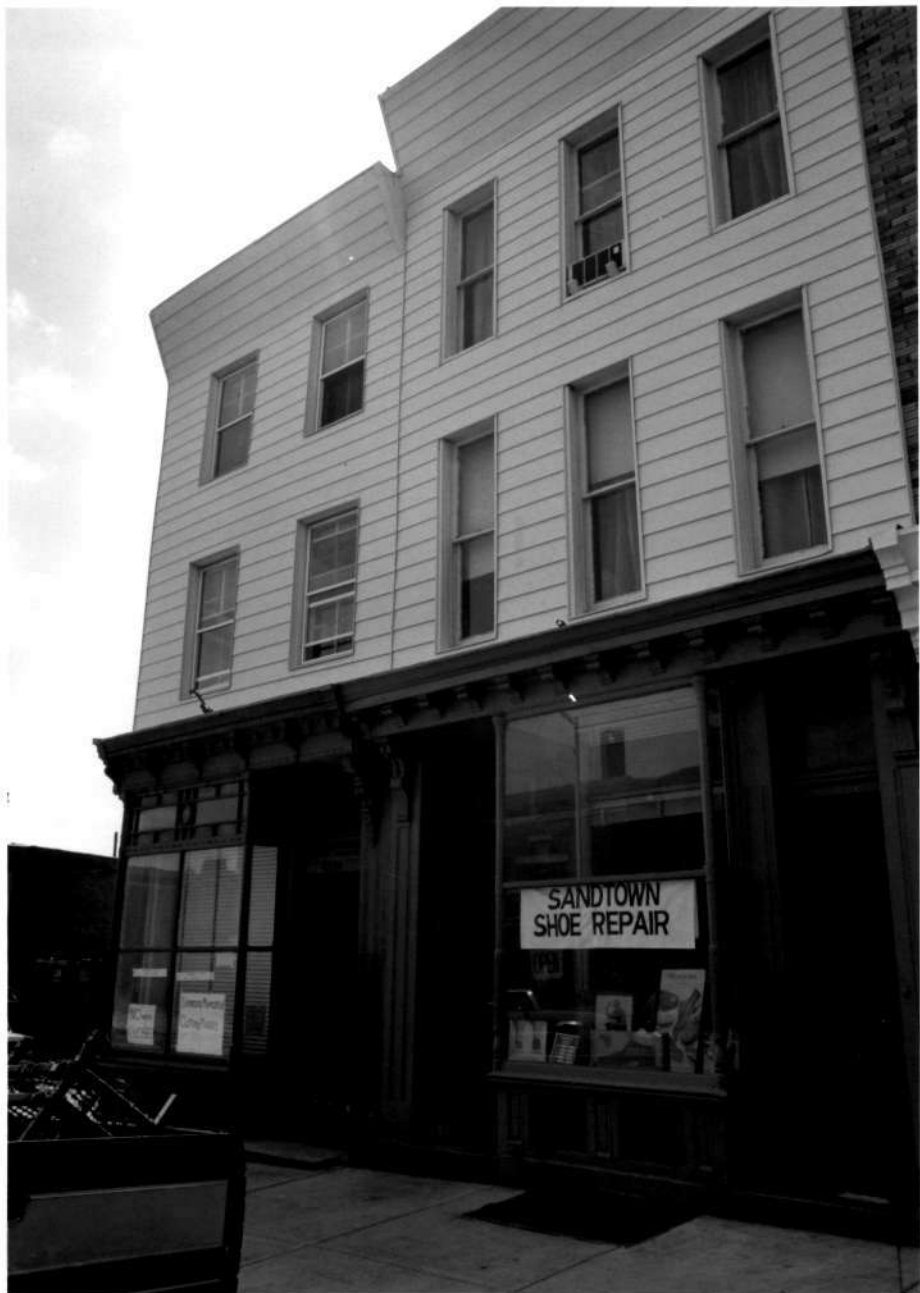
1 & 2

HISTORIC: TIN SHOP & HARNESS MAKER'S SHOP

CURRENT: CLOTHING MINISTRY & SHOE REPAIR

2334 1/2 36 PENNSYLVANIA AVE.

NORTHEAST ELEVATIONS

The more elegant of the two storefronts is #2334. It is a cast-iron framed, plate-glass storefront system, one-and-a-half bays wide. The display window contains four square panes of glass, topped with a decorative Queen Anne transom. To its north is a single-leaf entrance with a Queen Anne glass transom. Its storefront bracketed cornice is supported by larger end brackets at either end of the storefront. It is sawn and features jigsawn work in the frieze.

The storefront at #2336 has a basic Italianate cornice and a cast-iron colonnette display window system as well. This storefront may feature replacement glass, as proportions suggest the possibility of a missing original transom. The display window is currently divided only horizontally into two panes of glass. This first floor features an A-B-A, door-window-door arrangement. In the southernmost bay, there is a recessed entrance to the store. The middle bay features the display window, and the northern bay, a panelled entrance to the residences above. At the base of the composition is the original wooden (?) kickplate. The storefront cornice is a simple modillioned cornice supported by two brackets at either end. An extant cellar in the sidewalk reveals how goods were delivered and stored at the facility.

The residential windows on both units are flat-headed, although vinyl obscures their original detailing and cornice.

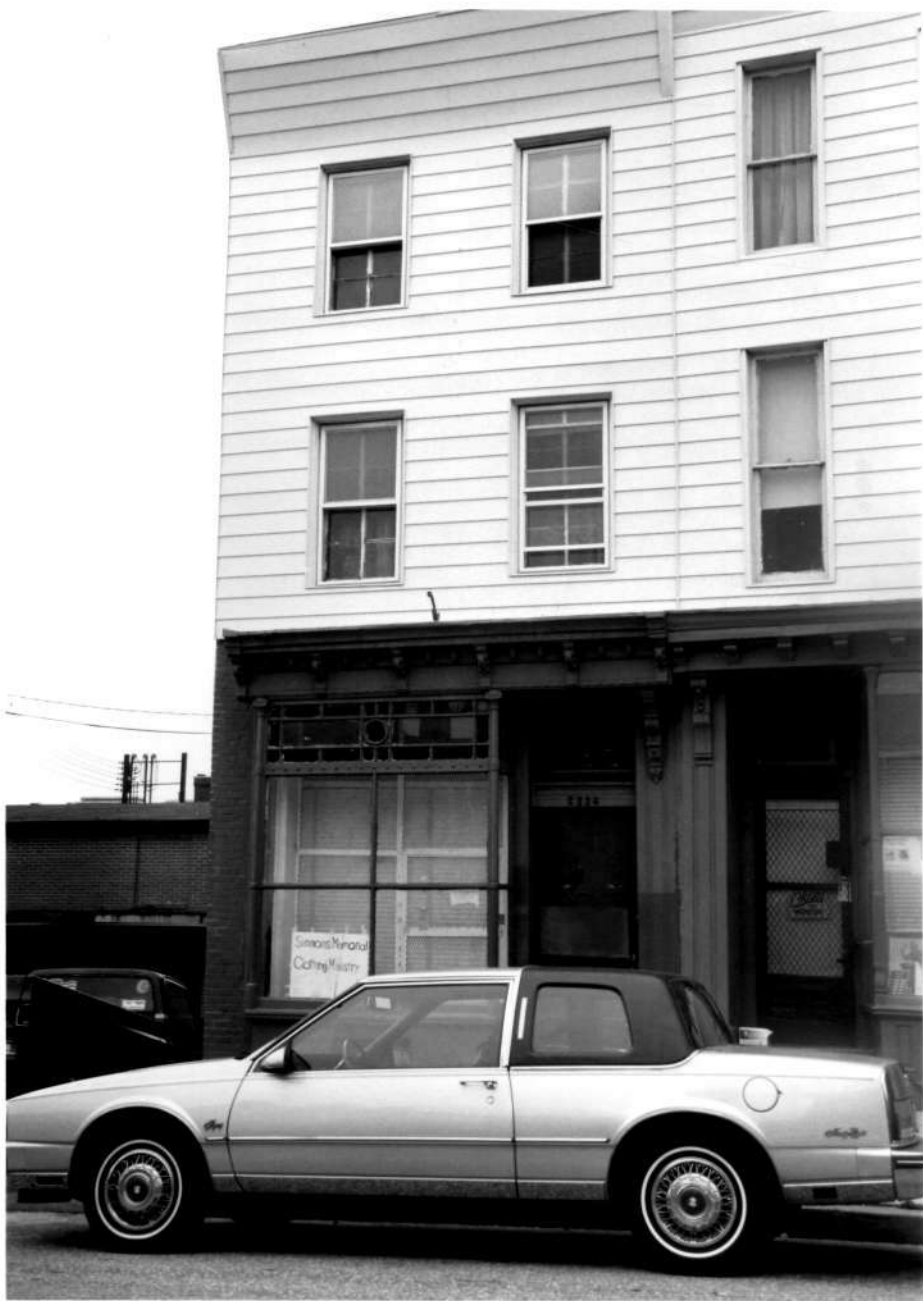
2 of 2

Historic: Storefront and Harness maker's shop

Current: Clothing Ministry and Sandtown Shoe Repair

2334 and 2336 Pennsylvania Avenue

NORTHEAST ELEVATIONS
